Westlands Water District Groundwater Pumping and Conveyance Project Draft Initial Study/Negative Declaration State Clearinghouse # 2020090040

Enclosure: Department of Water Resources' (DWR) Comments on the September 2020 Draft Initial Study / Negative Declaration (IS/ND) for Westlands Water District (District) Groundwater Pumping and Conveyance Project (Project)

CALIFORNIA AQUEDUCT SUBSIDENCE STUDY
San Luis Field Division
San Joaquin Field Division

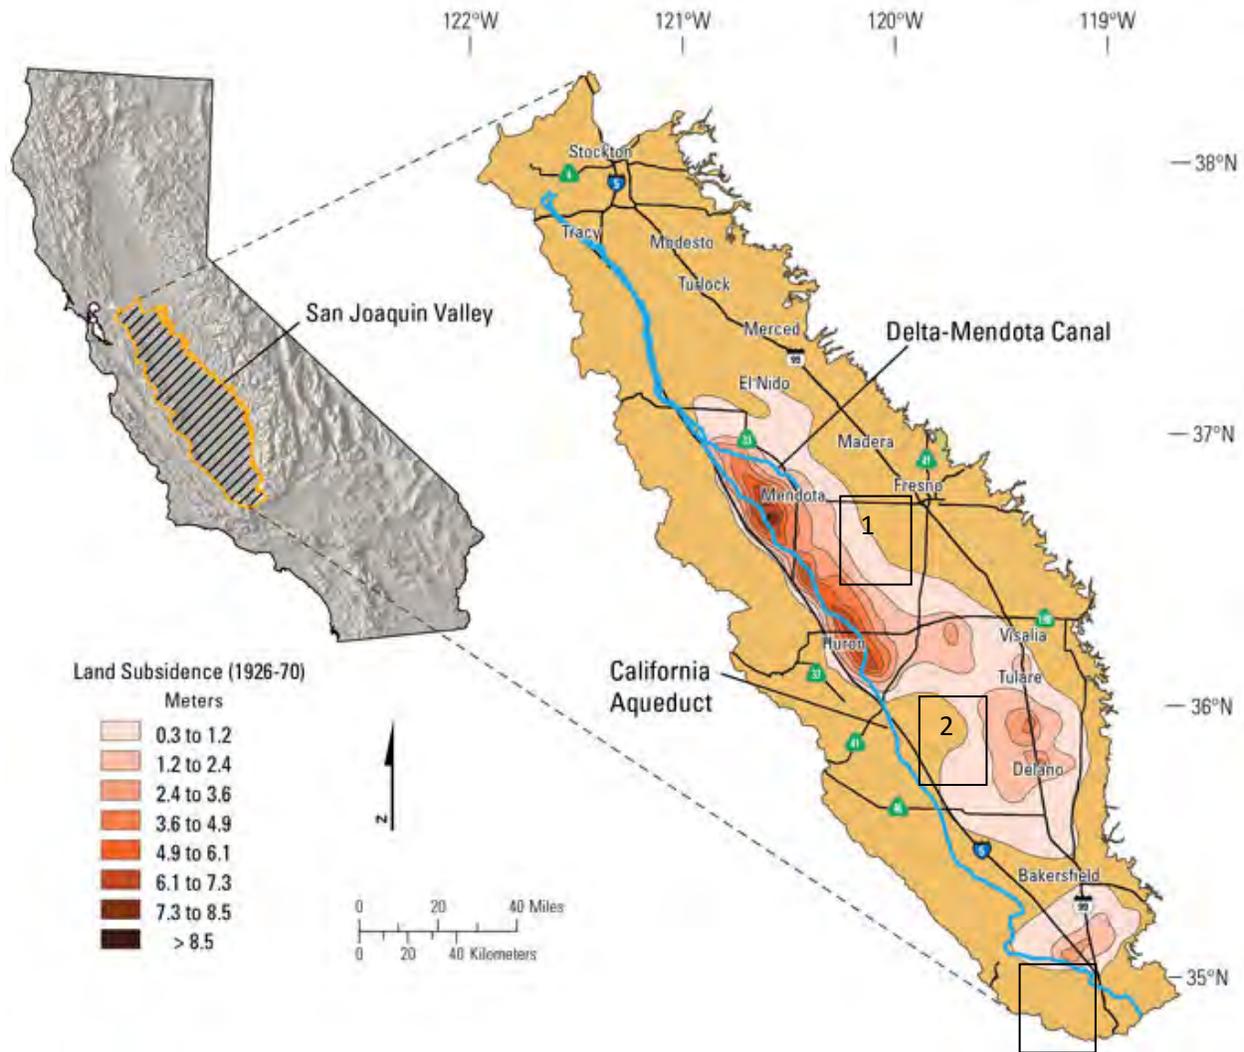
Figure 2-1 Location of the Areal Extent of Three Principal Areas of Subsidence Caused by Groundwater Withdrawals

The areal extent of three principal areas of subsidence caused by groundwater withdrawals are delineated in the Poland Reports as (1) Los Banos-Kettleman City (2400 square miles), (2) Tulare-Wasco (1400 square miles), and (3) Arvin-Maricopa (700 square miles) (Poland and others 1975, Thomas and Phoenix 1976, Ireland and others 1984). These areas are shown in Figure 2-1.

As mentioned in Chapter 2, three major subsiding areas related to groundwater withdrawal have been recognized in the Valley: (1) the Los Banos-Kettleman City area, largely in western Fresno County, (2) the Tulare-Wasco area, mostly in Tulare County, and (3) the Arvin-Maricopa area, in Kern County (Figure 2-1).

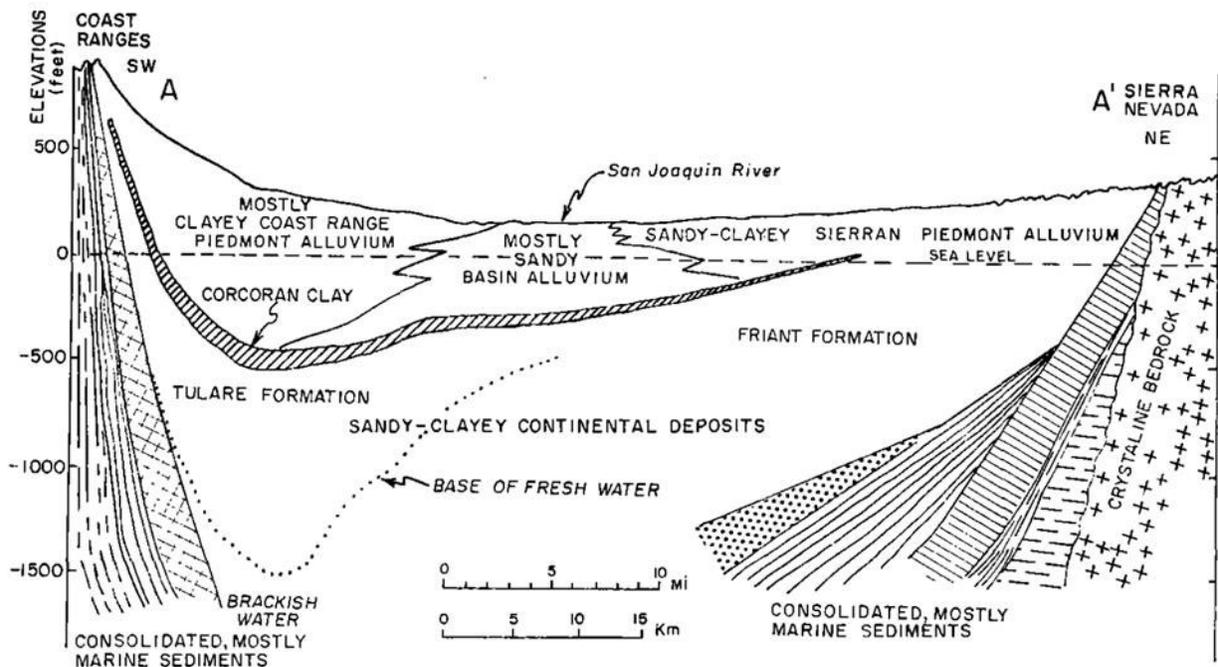
Figure 3-1 A Typical Cross Section of the Valley

Three distinct groundwater bodies have been delineated in the Valley and include (with increasing depth): (1) unconfined to semi-confined freshwater in alluvial deposits overlying a widespread lacustrine confining bed known as the Corcoran Clay Member of the Tulare Formation (Corcoran clay), (2) freshwater confined beneath the Corcoran clay in alluvial and lacustrine deposits, and (3) saline water, contained primarily in marine sediments, which underlie freshwater throughout most of the Valley (Page 1986). A typical cross section across the Valley is shown in Figure 3-1.

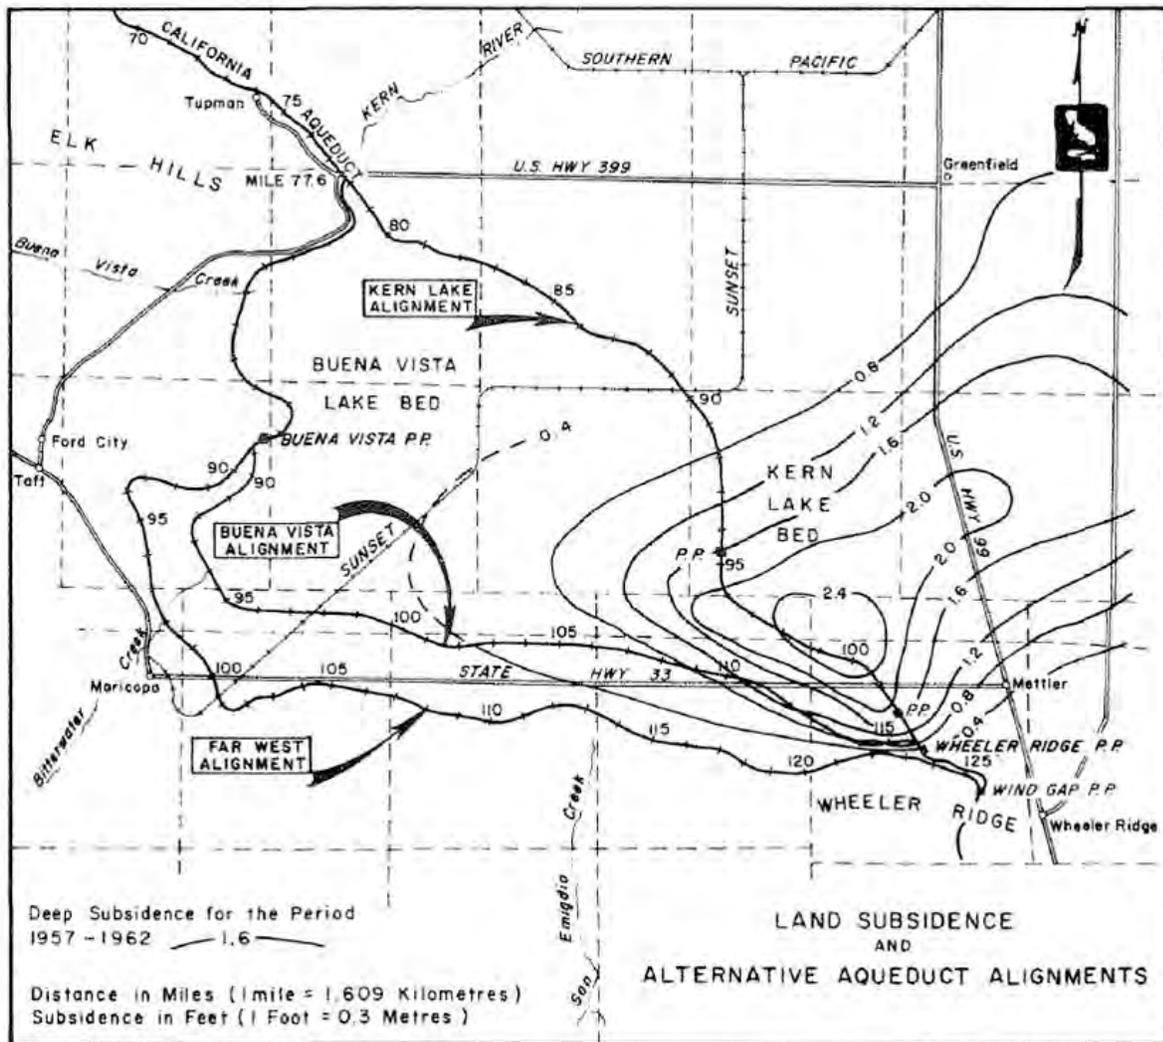
Figure 4-1 Location of Three Canal Alignments near the Buena Vista Lake Bed

Three different canal alignments near the Buena Vista Lake Bed (between Tupman Road and Wheeler Ridge) were considered by the DWR Division of Design and Construction, for the San Joaquin section of the Aqueduct (Figure 4-1). The three alignments included: (1) the Kern Lake Alignment (25 miles long) which crossed through an area of subsidence, (2) the Buena Vista Alignment (38 miles long) which went around the west side of the area and crossed the less severe zones of the subsidence area on the south side, and (3) the Far West Alignment (46 miles long) which skirted the edge of the subsidence area.

The study comparing the three alternatives found that the Kern Lake Alignment would be the most affected by deep subsidence and the alignment would potentially subside locally as much as 18 feet from

1970 to 2000. Based on the 1970 pre-subsidence design, the canal would require a trapezoidal shaped canal with 2:1 side slopes, 24 feet of water depth, and a top width of 120 feet. In order to accommodate the predicted subsidence (18 feet by the year 2000), the canal would require a trapezoidal shaped canal with 2:1 side slopes, 42 feet of water depth, and a top width of 192 feet to maintain the water surface at pre-subsidence 1970s level. That was an increase of 18 feet of water depth, and 72 feet of top width. That alternative would have quadrupled the earthwork, increased the cost associated with extra concrete lining, raised structures, and required additional planning to maintain water quality. There would also be additional engineering for other unforeseen problems, plus the costs of controlling plant growth, sediment, and seepage. The Kern Lake Alignment was deemed the least economically feasible.

The Buena Vista Alignment would have been less affected by deep subsidence. The study showed that this alignment would subside approximately 10 feet from 1970 to 2000. Although this alignment was 13 miles longer than the Kern Lake Alignment, the costs associated with subsidence for this alternative were much less.

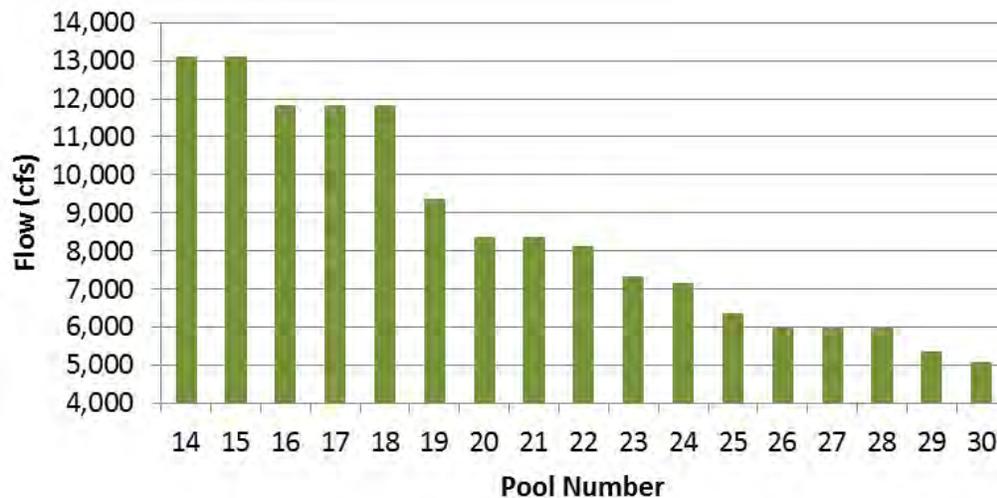
Figure 5-1 Variation of Aqueduct Pool Design Capacity

As originally designed, a number of turnouts are used to divert water from the San Luis Canal and the Aqueduct as water is transported south. As a result, the Aqueduct size has been reduced in the downstream direction. Table 5-1 gives the design flow capacity and approximate size of the Aqueduct section for pools downstream of Dos Amigos Pumping Plant (DAPP). The change in designed flow capacity of the Aqueduct is shown in Figure 5-1. The Aqueduct was sized to convey 8,350 cfs to the end of the San Luis Canal. From the end of the San Luis Canal, the flow of Aqueduct gradually tapers from 8,100 cfs to 5,050 cfs at Buena Vista Pumping Plant (BVPP). The Aqueduct was sized such that the maximum monthly water demand could be delivered through a reach by maintaining a constant head and flow.

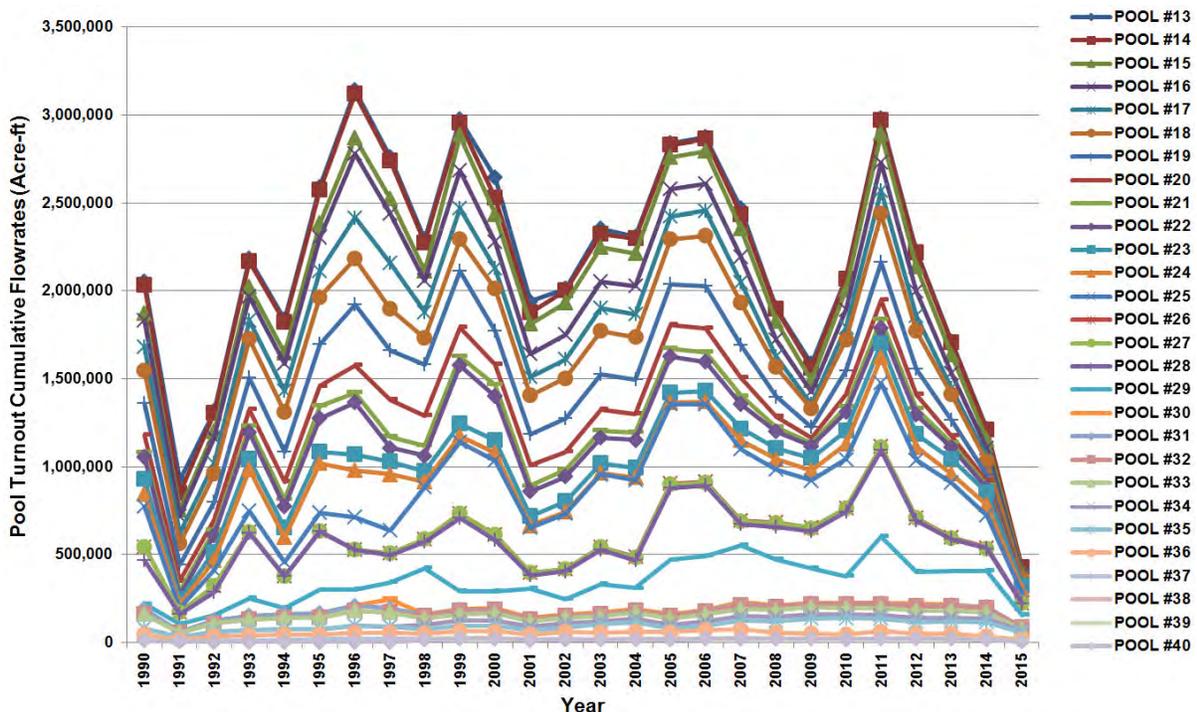
Figure 5-2 Total Flowrate from Turnouts for Pools 13 to 40 (Cumulative Flowrate, per Pool Over Time)

Because there are currently 245 turnouts in Pools 13 through 40, this analysis combined the individual deliveries for each turnout into an overall delivery total per pool. In order to identify delivery trends, the overall total delivery per pool was graphed from 1990 through 2015. Figure 5-2 displays the cumulative turnout deliveries between 1990 and 2015. The cumulative per pool delivery represents the amount of water delivered for all of the turnouts that are in a particular pool. The plot of cumulative delivery per pool did not show any increasing trends with time (that may correspond with the increase in turnouts). The increases and decreases seem to come from the varying allocations throughout the years.

From 1990 to 2000, the turnout flowrates were summed into one turnout per pool. The data prior to 2000 were not reliable for establishing a turnout count for each year. While evaluating the data on a 5-year interval, (Figure 5-2) it was noted that there was an average increase of one turnout per pool from 2000 to 2005, from 2005 to 2010, and from 2010 to 2015. By evaluating the cumulative flowrate in each pool and the amount of turnouts per year, no significant trends were observed.

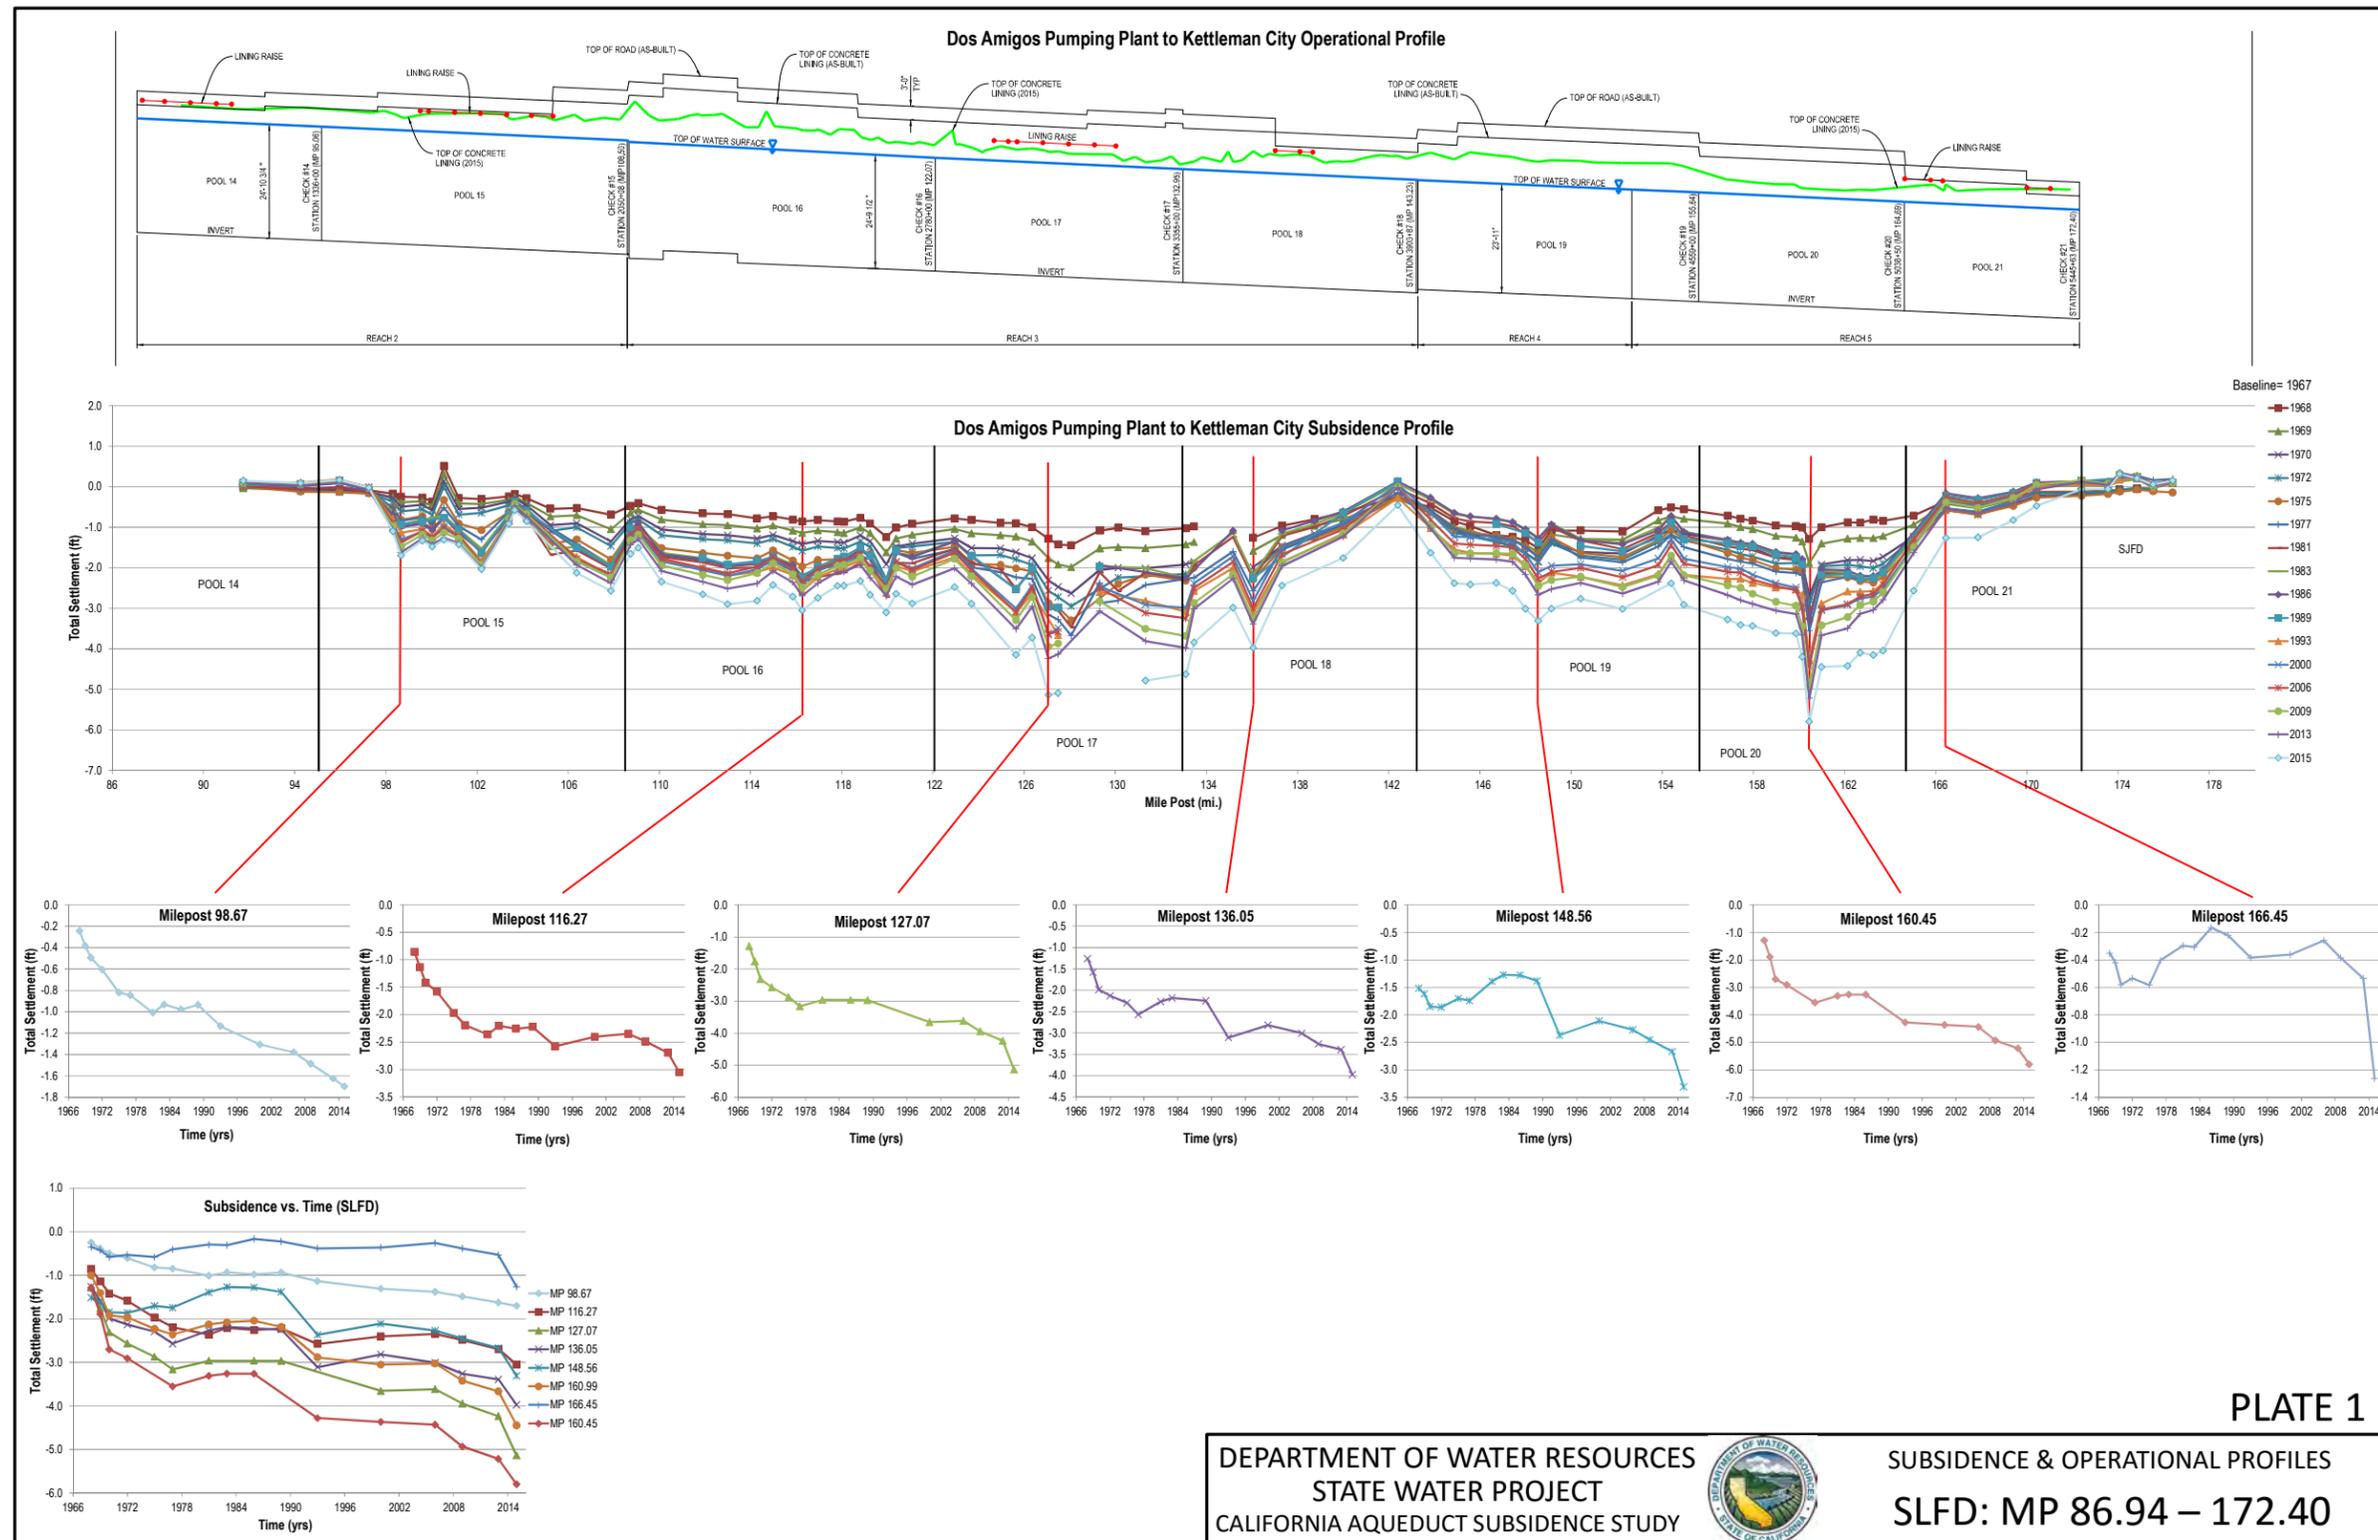
Figure 6-1 Subsidence and Operational Profiles - San Luis Field Division - Plate 1

1. A data set of 90 benchmarks, located on structures and top of the lining, was selected based on historic regional data benchmarks that were used in past subsidence studies. The yearly data of these benchmarks, identified by their milepost location, were plotted, milepost versus total subsidence in a given year, to show the progression of subsidence from 1967 to 2015. That change was calculated by subtracting a recorded elevation for a particular benchmark, at each year, from the baseline value recorded in 1967. The process was repeated for all of the benchmarks and the difference in elevation was plotted out on the y-axis, for a given milepost (x-axis). The leveling data from these benchmarks are summarized in Section 6.3 and are profiled in the subsidence profile graphs on Plates 1 through 9. Plate 1 is a plot of the SLFD. Plates 2 through 9 are plots of Aqueduct Pools 14 through 21.

2. A data set of 136 benchmarks, located on the top of the lining, was also extracted from the 940 benchmarks that were surveyed along the San Luis Canal in 2015. Their elevations were plotted on the operational profile graphs on Plates 1 through 9. They show the total subsidence that has occurred on the lining up to 2015.

Plate 1. SLFD Subsidence & Operational Profiles

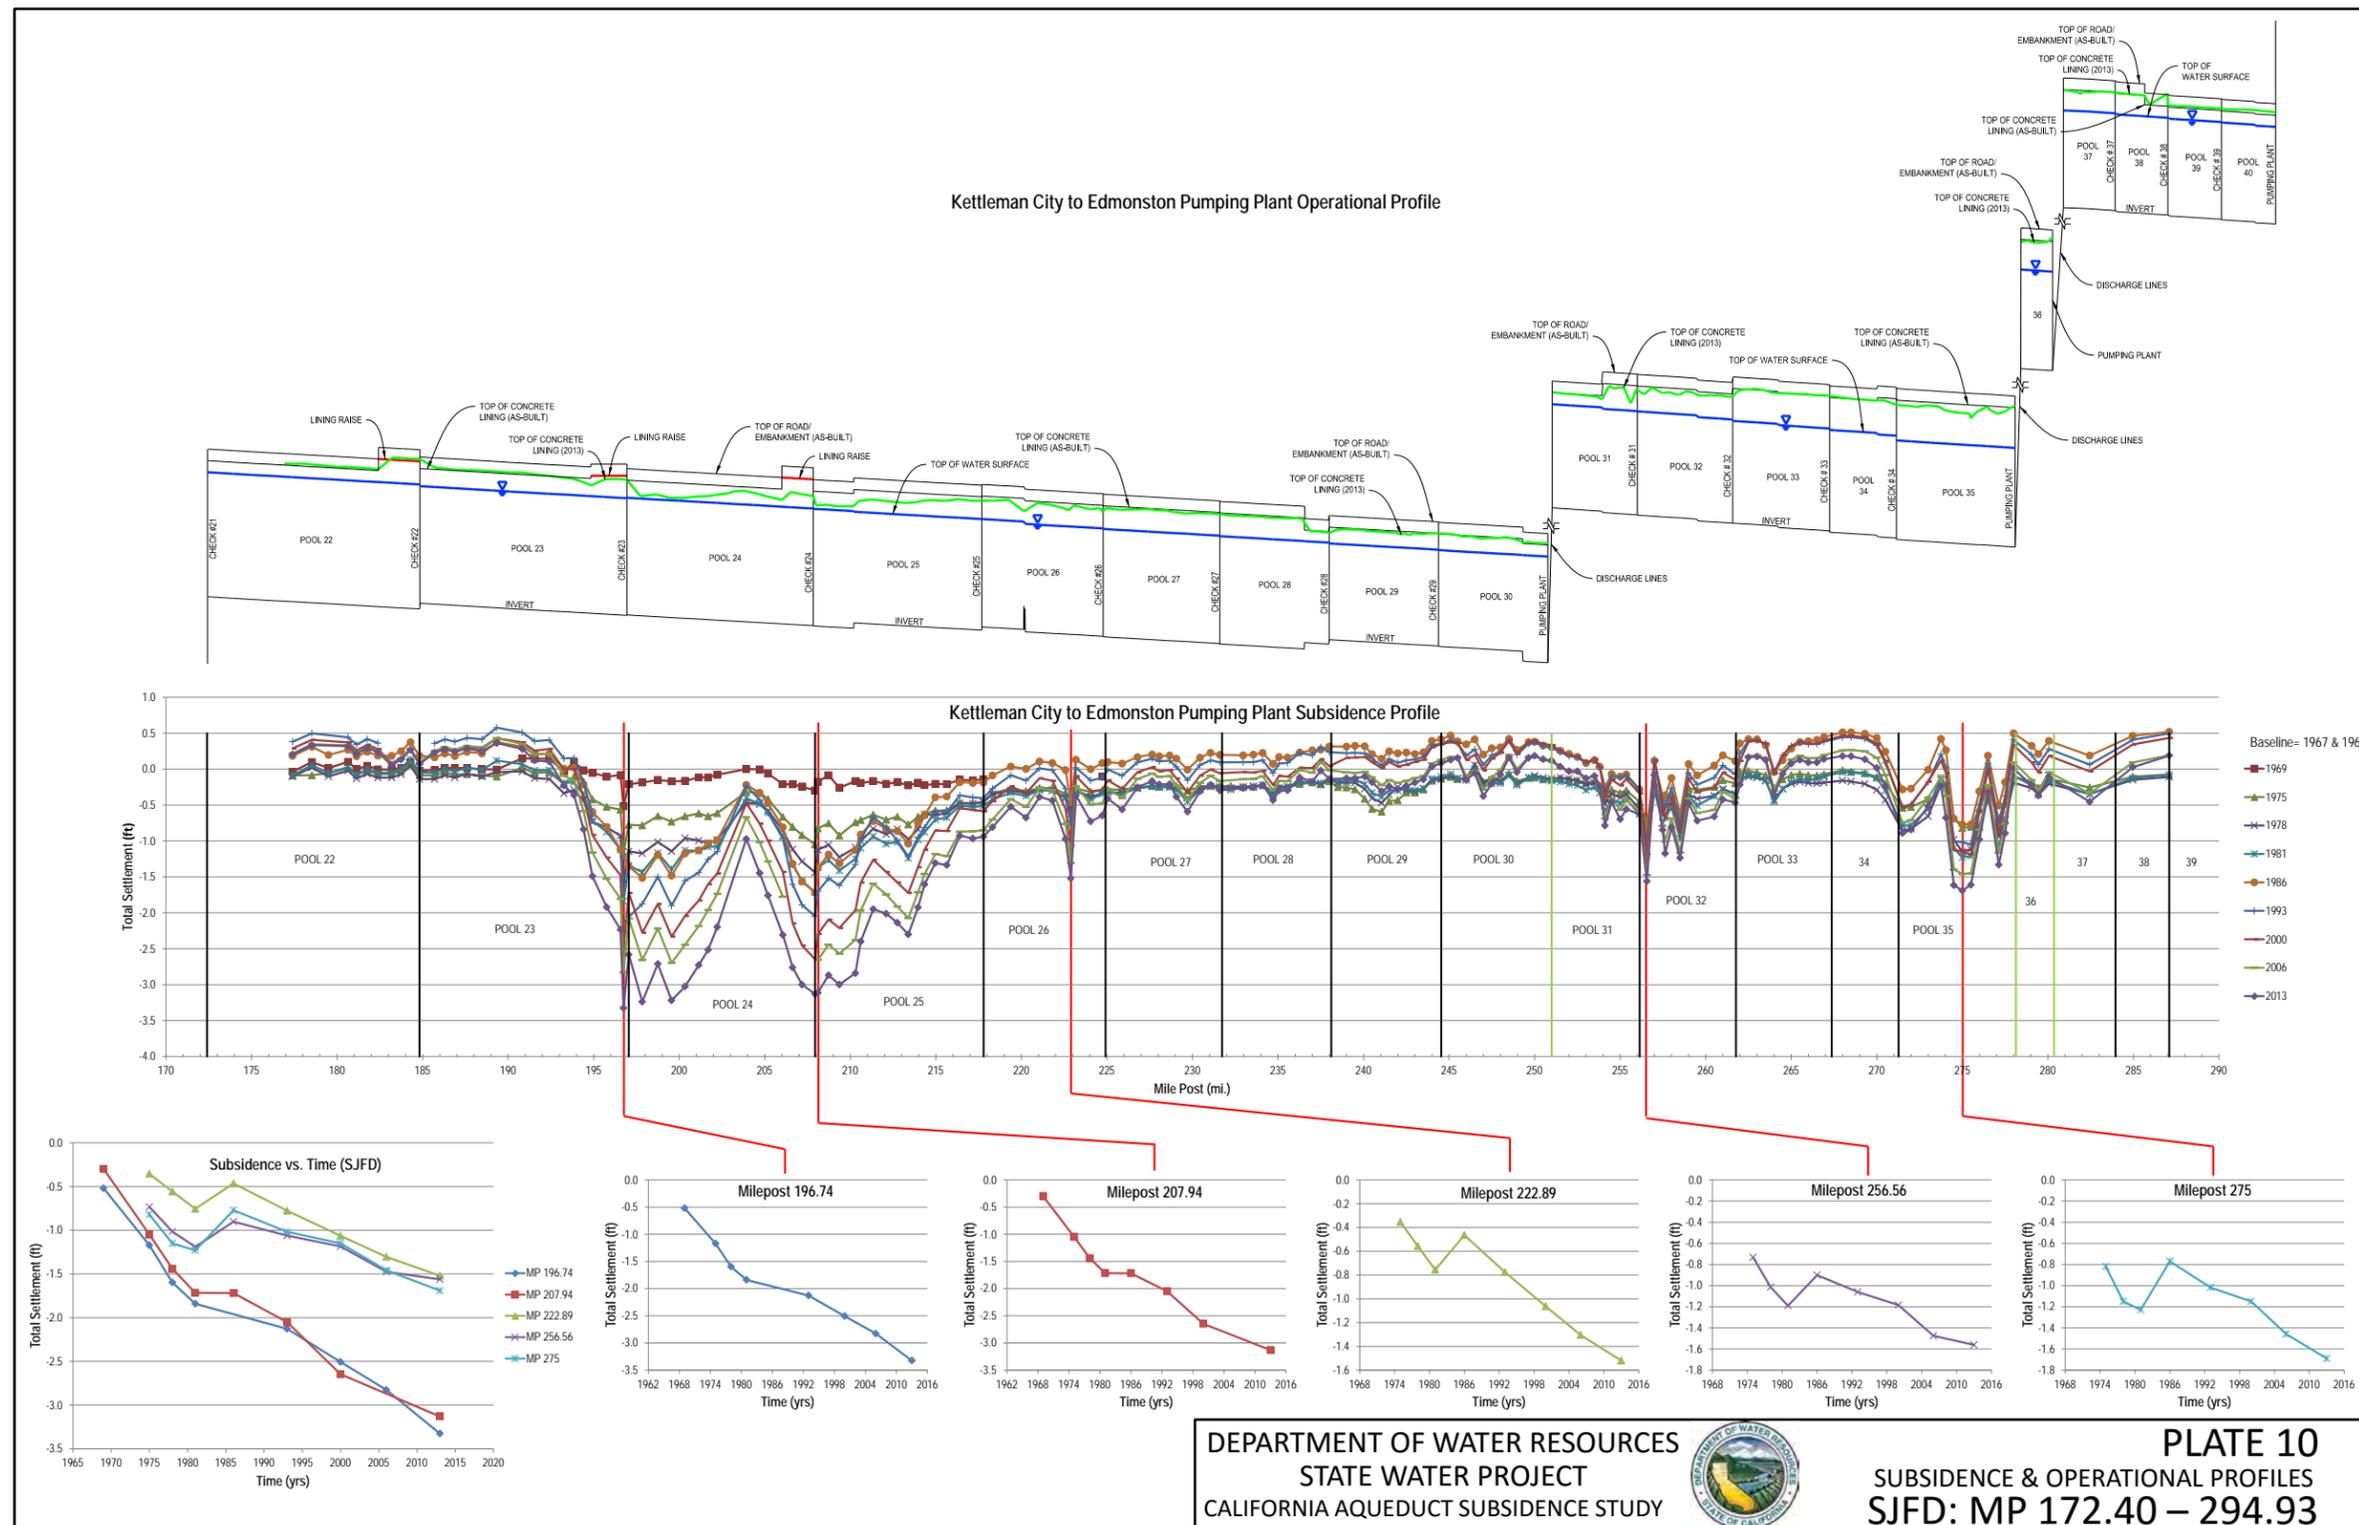
Figure 6-2 Subsidence and Operational Profiles - San Joaquin Field Division - Plate 10

2. A data set of 249 benchmarks located on the top of the lining, was also extracted from the 1,009 benchmarks that were surveyed in the SJFD during 2013. Their elevations were plotted on the operational profile graphs on Plates 10 through 27. They show the total subsidence that has occurred on the lining up until 2013.

Plate 10. SJFD Subsidence & Operational Profiles
